INDOOR AIR QUALITY ASSESSMENT

**Brockton Public Library
304 Main Street
Brockton, Massachusetts**

Prepared by:
Massachusetts Department of Public Health
Center for Environmental Health
Emergency Response/Indoor Air Quality Program
June 2005

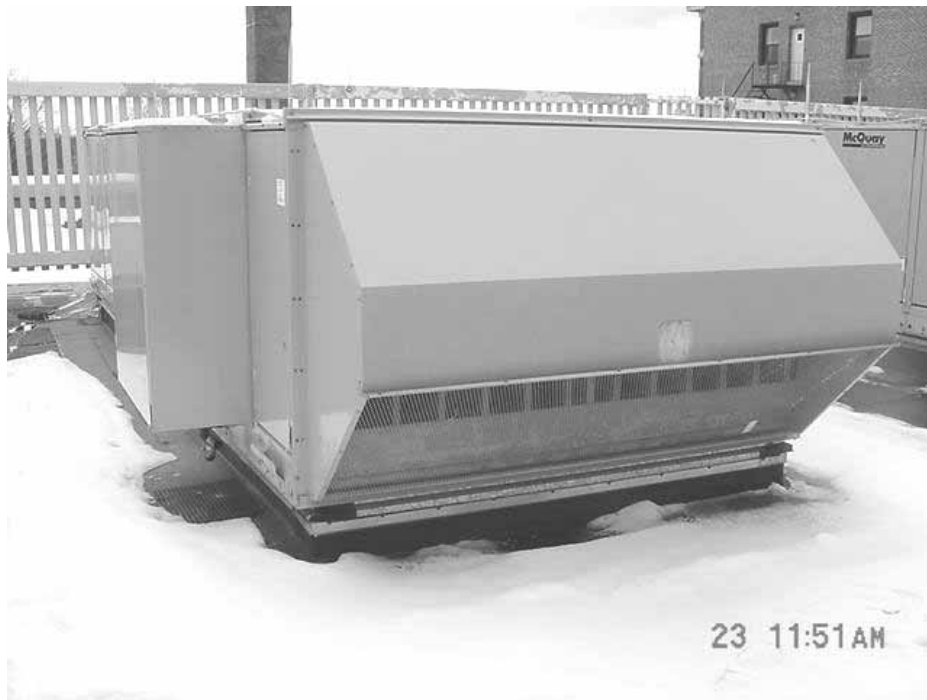
Picture 1

Rooftop Air Handling Unit

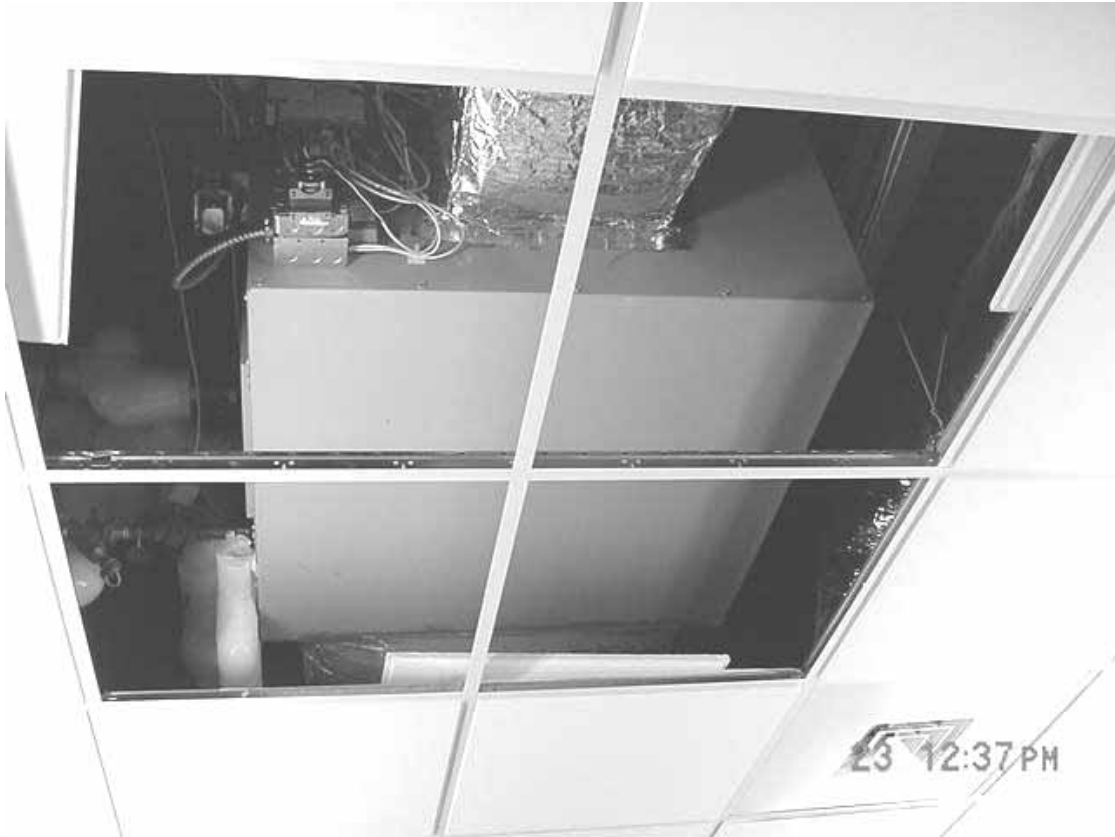
Picture 2

Fan Coil Unit above Ceiling Tile System

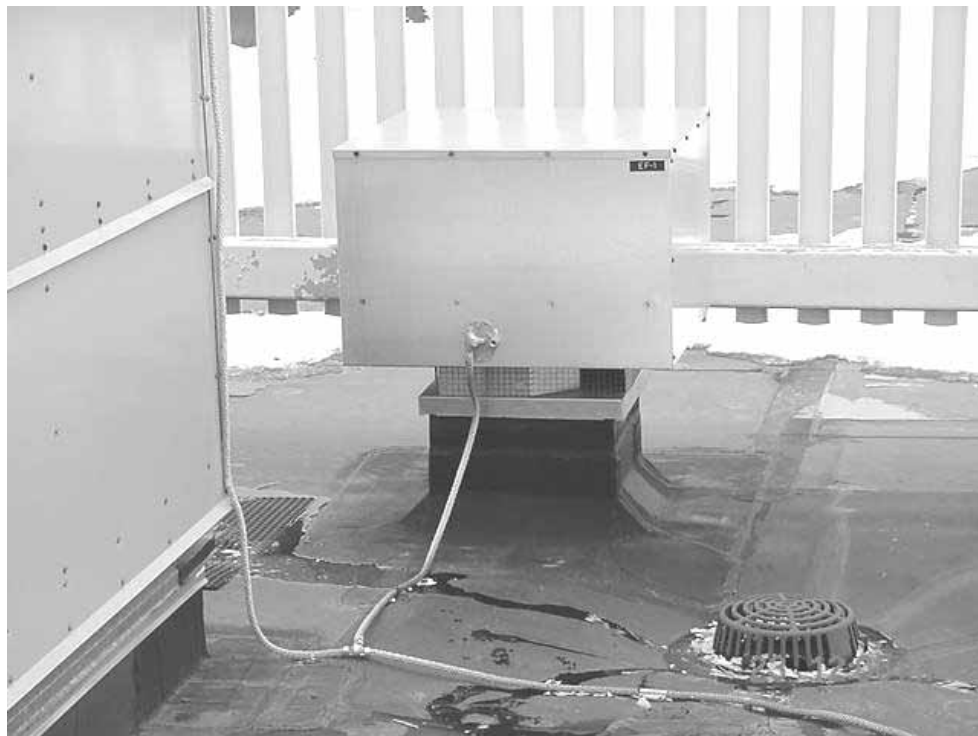
Picture 3

Exhaust ventilation is provided by rooftop exhaust motors (Picture 3) ducted to ceiling-mounted vents throughout the building. This system was operating during the assessment. In one case, the children's library has a ceiling-mounted air diffuser located

Rooftop Exhaust Motor

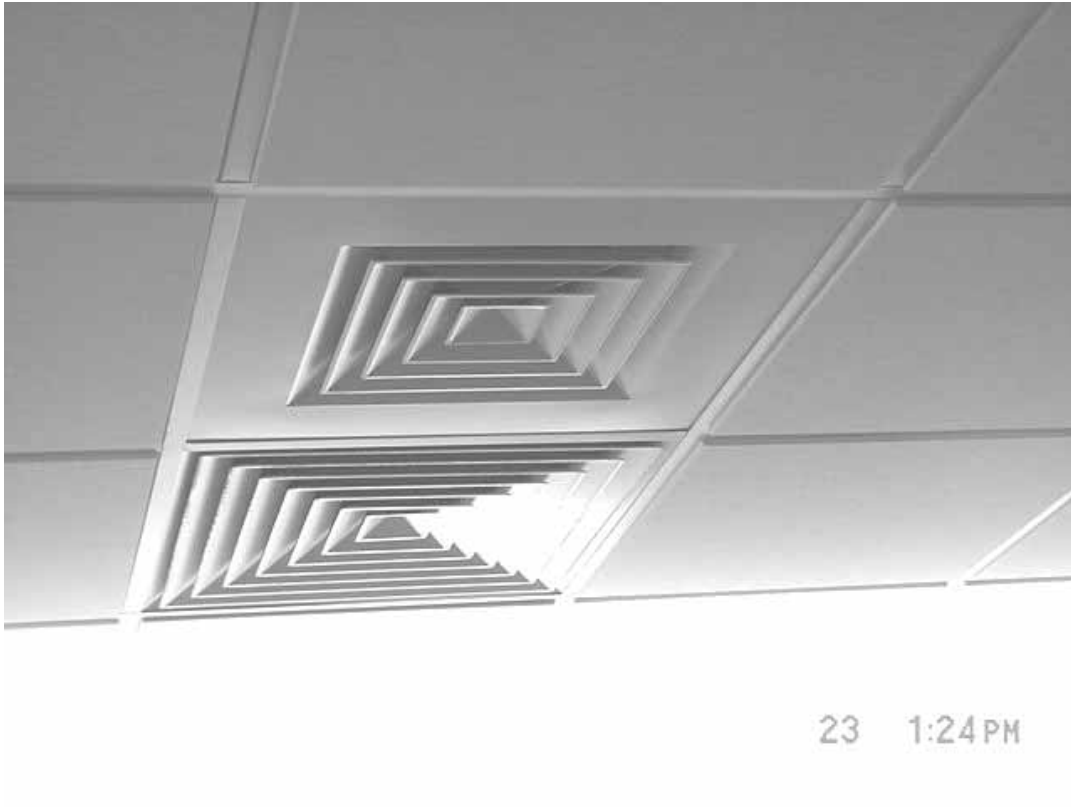
Picture 4

directly next to an exhaust vent (Picture 4). As a result, the supply air from the diffuser is drawn into the exhaust vent without circulating, a condition known as short-circuiting.

Supply and Exhaust Vent Directly next to Each Other in Children's Library

1. Continue working with HVAC vendor to make adjustments to the mechanical ventilation system, which may include software and computer control upgrades to improve the comfort of occupants.
2. Relocate exhaust vent in children's library (Picture 4) away from supply vent to prevent short-circuiting.

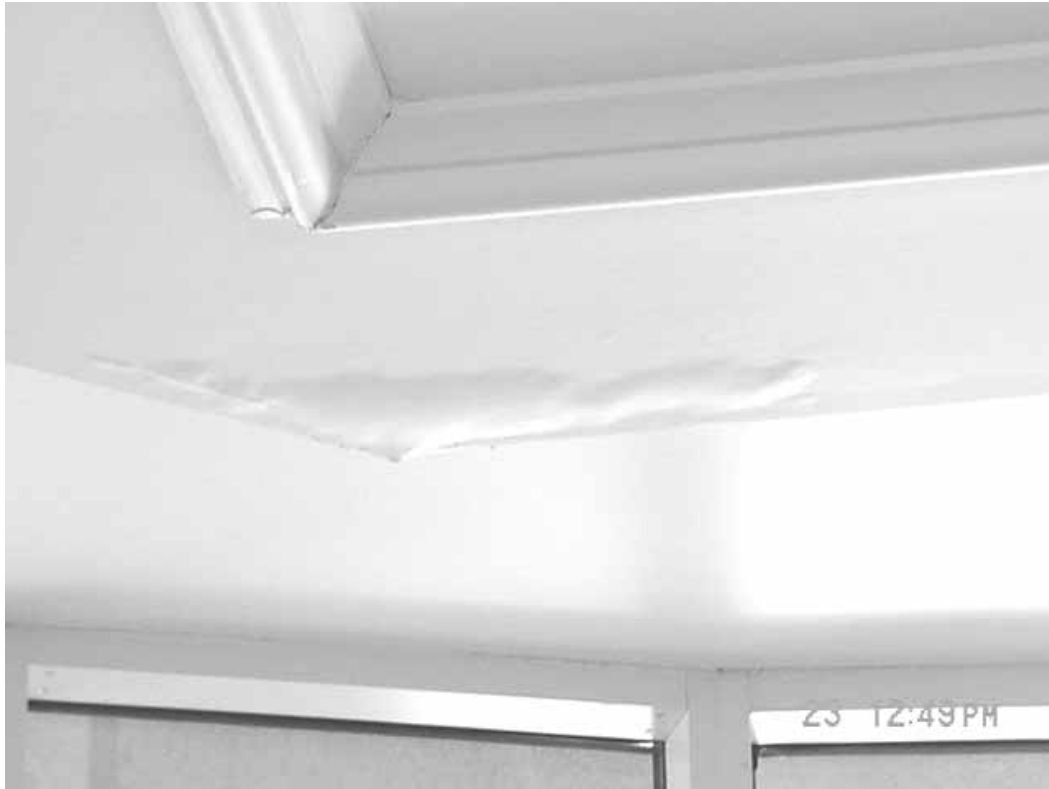
Picture 5

Water-damaged/bubbling paint was observed in the stairwell leading to White Avenue (Picture 5). Water damage is most likely the result of water penetration through the building envelope, primarily around the cylindrical architecture above the White Avenue entrance (Picture 6). Although water damage appeared minimal, repeated water damage to porous building materials (e.g., gypsum wallboard, wood) can result in microbial growth. The US Environmental Protection Agency (US EPA) and the American Conference of Governmental Industrial Hygienists (ACGIH) recommend that porous materials be dried with fans and heating within 24 to 48 hours of becoming wet (US EPA, 2001; ACGIH, 1989). If porous materials are not dried within this time frame, mold growth may occur.

Water Damaged/Bulging Paint in White Street Stairwell

8. Repair leaks and repair/replace any water-damaged materials.
9. For buildings in New England, periods of low relative humidity during the winter are often unavoidable. Therefore, scrupulous cleaning practices should be adopted to minimize common indoor air contaminants whose irritant effects can be enhanced when the relative humidity is low. To control for dusts, a high efficiency particulate arrestance (HEPA) filter equipped vacuum cleaner *in conjunction* with wet wiping of all surfaces is recommended. Avoid the use of feather dusters. Drinking water during the day can help ease some symptoms associated with a dry environment (throat and sinus irritations).

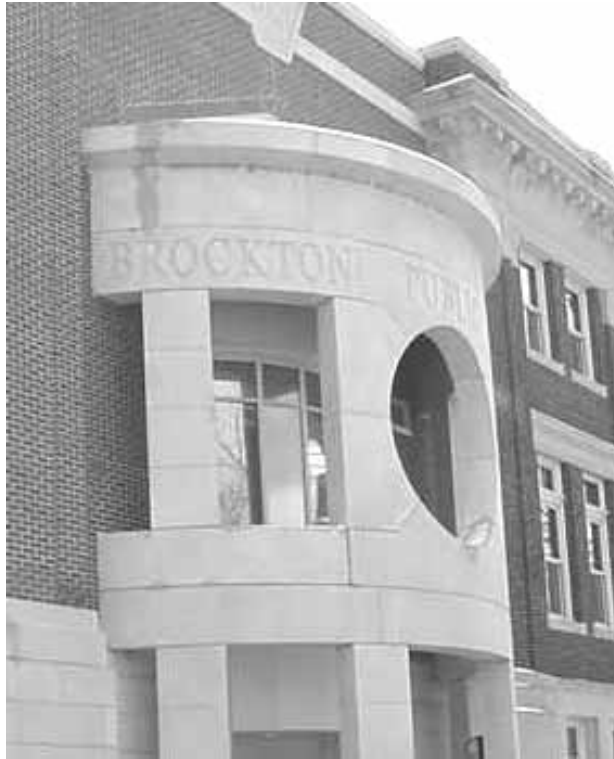
Picture 6

Architecture Outside of White Street Entrance Where Water Damage has Occurred

6. Relocate work area behind circulation desk in children's library away from vents.
7. Consider consulting with an architect, masonry firm or general contractor regarding the integrity of the building envelope, primarily concerning water penetration through the exterior wall at the White Avenue entrance.

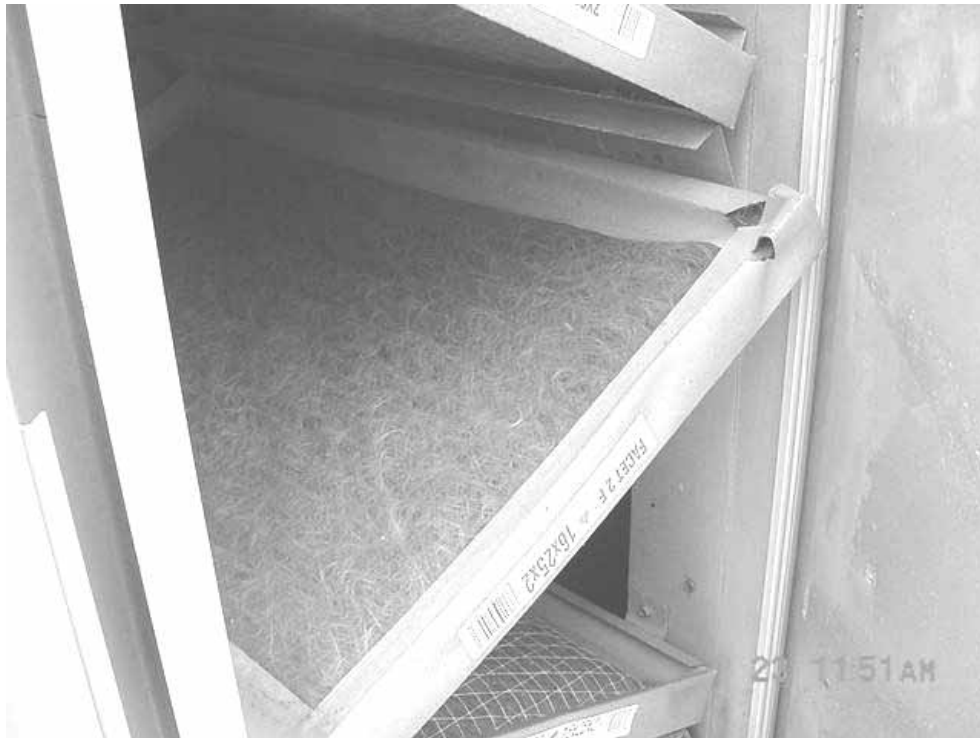
Picture 7

AHUs are equipped with filters that strain particulates from airflow. According to BPL staff, filters are changed three to four times a year. However, the type of filters installed provide minimal filtration of respirable dusts (Picture 7). In order to decrease aerosolized particulates, disposable filters with an increased dust spot efficiency can be installed. The dust spot efficiency is the ability of a filter to remove particulates of a certain diameter from air passing through the filter. Filters that have been determined by ASHRAE to meet its standard for a dust spot efficiency of a minimum of 40 percent (Minimum Efficiency Reporting Value equal to 9) would be sufficient to reduce many airborne particulates (Thornburg, D., 2000; MEHRC, 1997; ASHRAE, 1992). Note that increasing filtration can reduce airflow (a condition known as pressure drop), which can subsequently reduce the efficiency of the AHU due to increased resistance. Prior to any increase of filtration, each AHU should be evaluated by a ventilation engineer to ascertain whether it can maintain function with more efficient filters.

Fibrous Mesh Filters in Rooftop Air Handling Units

4. Consider providing formal training to *multiple* individuals to create redundancy to ensure proper operation and maintenance of the HVAC system.
5. Consider increasing the dust-spot efficiency of HVAC filters. Prior to any increase of filtration, each piece of air handling equipment should be evaluated by a ventilation engineer as to whether it can maintain function with more efficient filters.

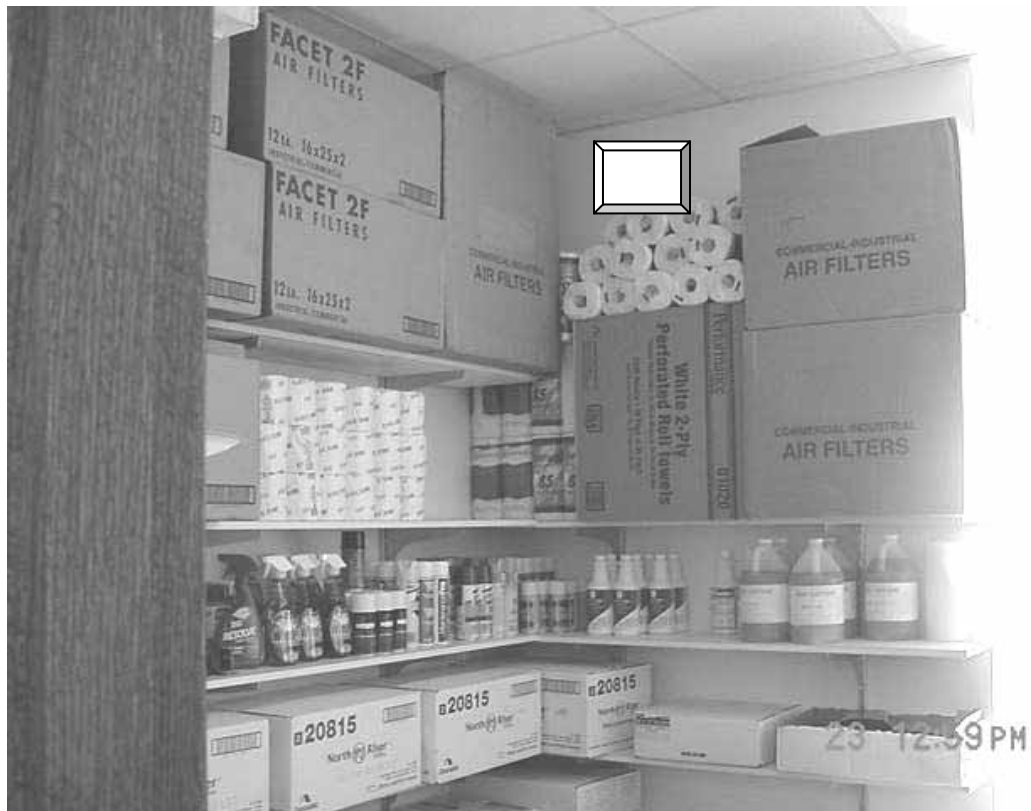
Picture 8

The custodial office on the first floor is used for storage of a number of cleaning chemicals/agents. These areas are normally equipped with local exhaust ventilation to remove odors. The exhaust vent for this area is located in a closet used for computer network equipment. MDPH staff recommended installing a passive vent in the wall (Picture 9) to allow air to flow from the custodian's office into the closet and subsequently be removed by the local exhaust vent.

Custodial Storage Office, White Box Indicates Location Recommended for Passive Vent

10. Install passive vent in upper wall of custodial office on first floor, as shown in Picture 8, to provide exhaust ventilation.
11. Seal the boiler room doors from adjacent areas (elevator shaft, stairwell, etc) (Picture 9) with polyethylene plastic sheeting and duct tape on both sides of the boiler room door in case of another glycol spill. In addition, seal opposing sides to provide a dual barrier. The area should also be depressurized by deactivating the HVAC motor shown in Picture 10 and by venting the room out the make-up air vent using flexible ductwork and fans (Picture 11).
12. Refer to resource manuals and other related indoor air quality documents for further building-wide evaluations and advice on maintaining public buildings. These materials are located on the MDPH's website.

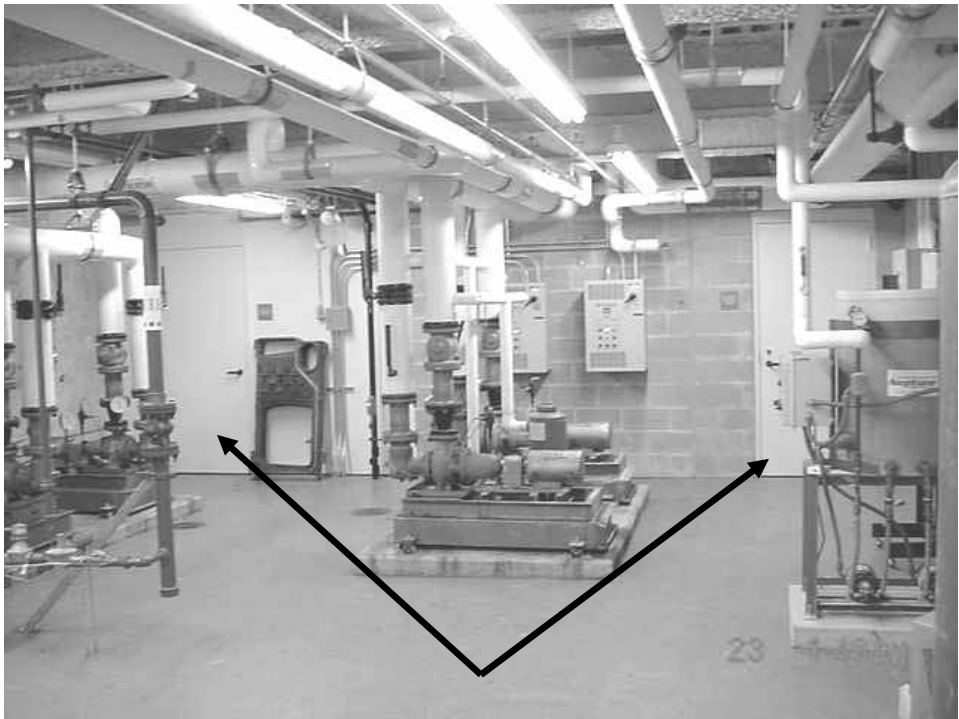
Picture 9

Finally, BPL staff reported that a boiler malfunction had occurred several months prior to the MDPH assessment. At time of the boiler malfunction, several gallons of glycol, a coolant material, reportedly spilled onto the floor. As a result, odors migrated into the adjacent elevator shaft room and stairwell to the first floor. The movement of the elevator in the shaft can act like a piston, pressurizing and depressurizing air in the elevator shaft, which can then force and draw odors into other areas of the building. At the time of the assessment the boiler had been repaired and the glycol spill was cleaned and no evidence or lingering odors were detected. BPL staff did, however, ask advice on corrective actions in the case of any future boiler problems. These suggestions are listed in the Conclusions/Recommendations section at the end of this assessment.

Doors in Boiler Room, Stairwell Door to First Floor not Shown

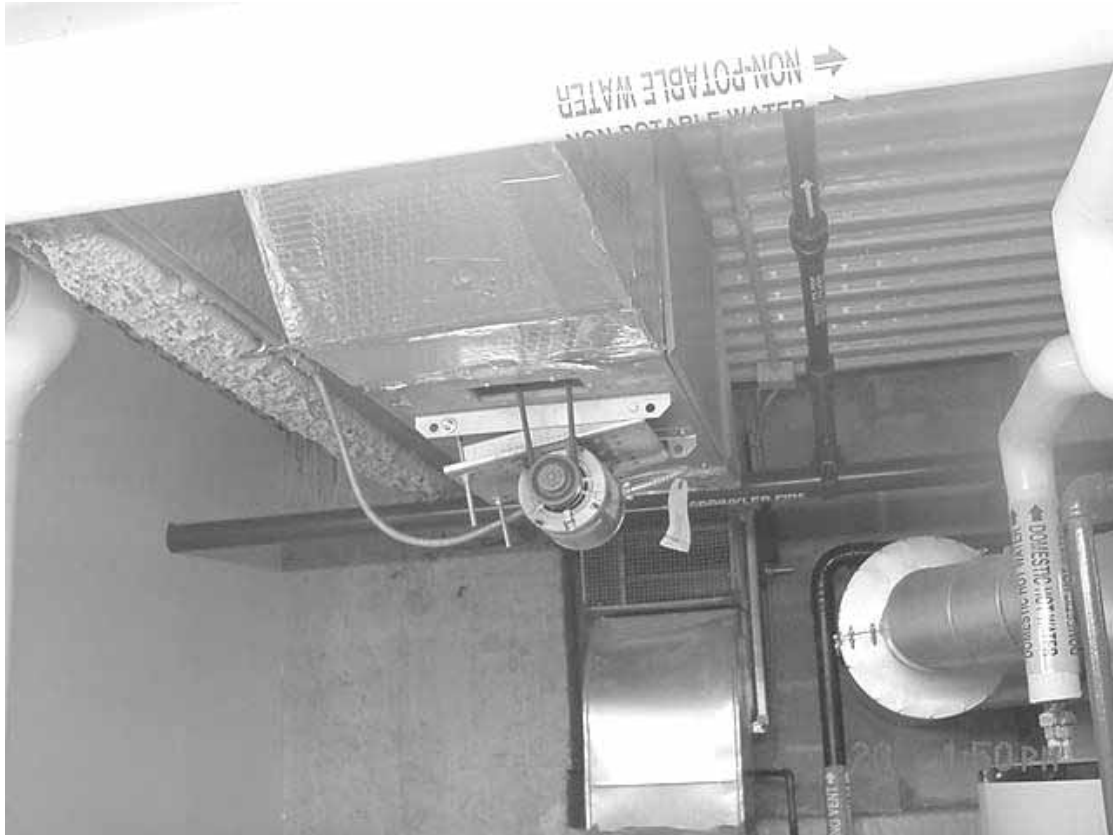
Picture 10

Close-Up of Boiler Room Make Up Air Vent and HVAC Motor

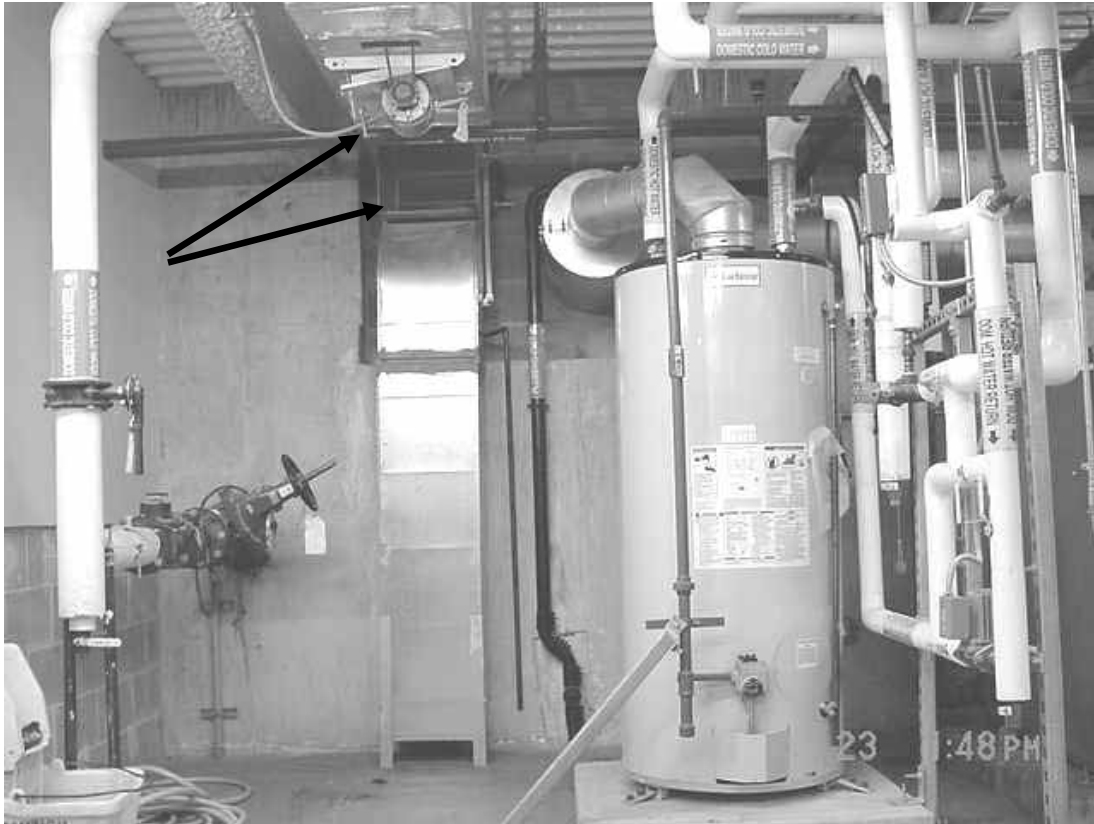
Picture 11

Long View of Boiler Room Make Up Air Vent and HVAC Motor
